C. B. & Q. RENOVATES "DENVER ZEPHYRS"

After 13 years and 4½ million miles of revenue service the stainless steel shows no deterioration — Insulation is renewed and other changes made in a complete overhaul

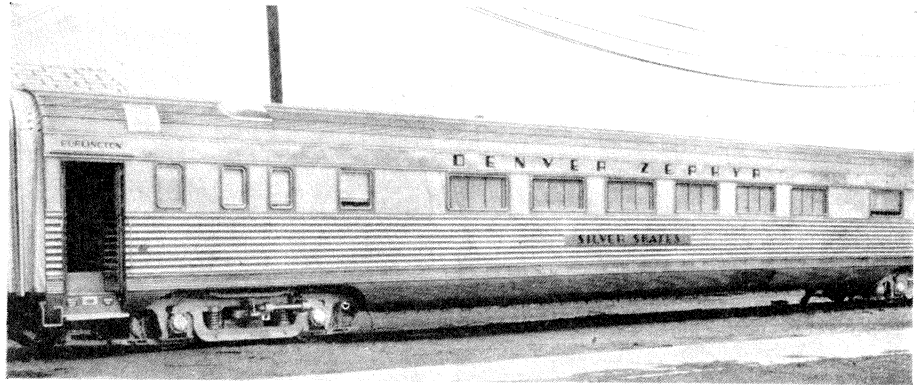
A renovated car just out of the Aurora shops

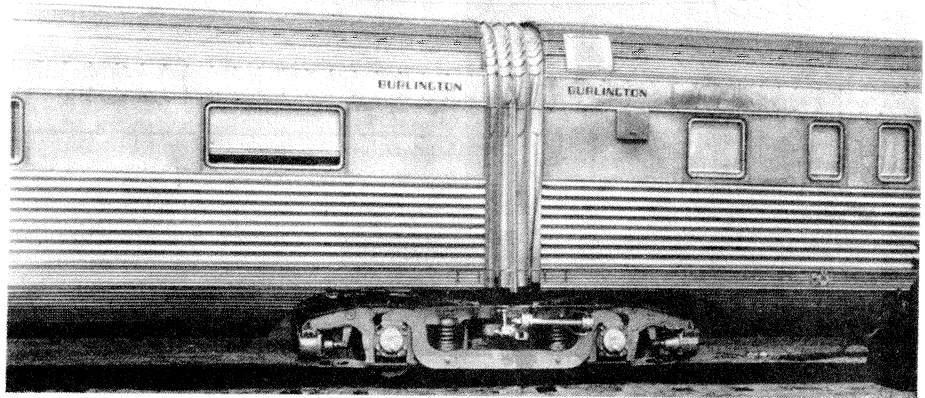
Trucks were rebuilt with coil instead of elliptic springs

All trucks were completely dismantled, truck frames sand blasted, checked for any defects and also trammed, then built up and equipped with General Steel Castings roll stabilizers and coil springs in place of elliptic springs.

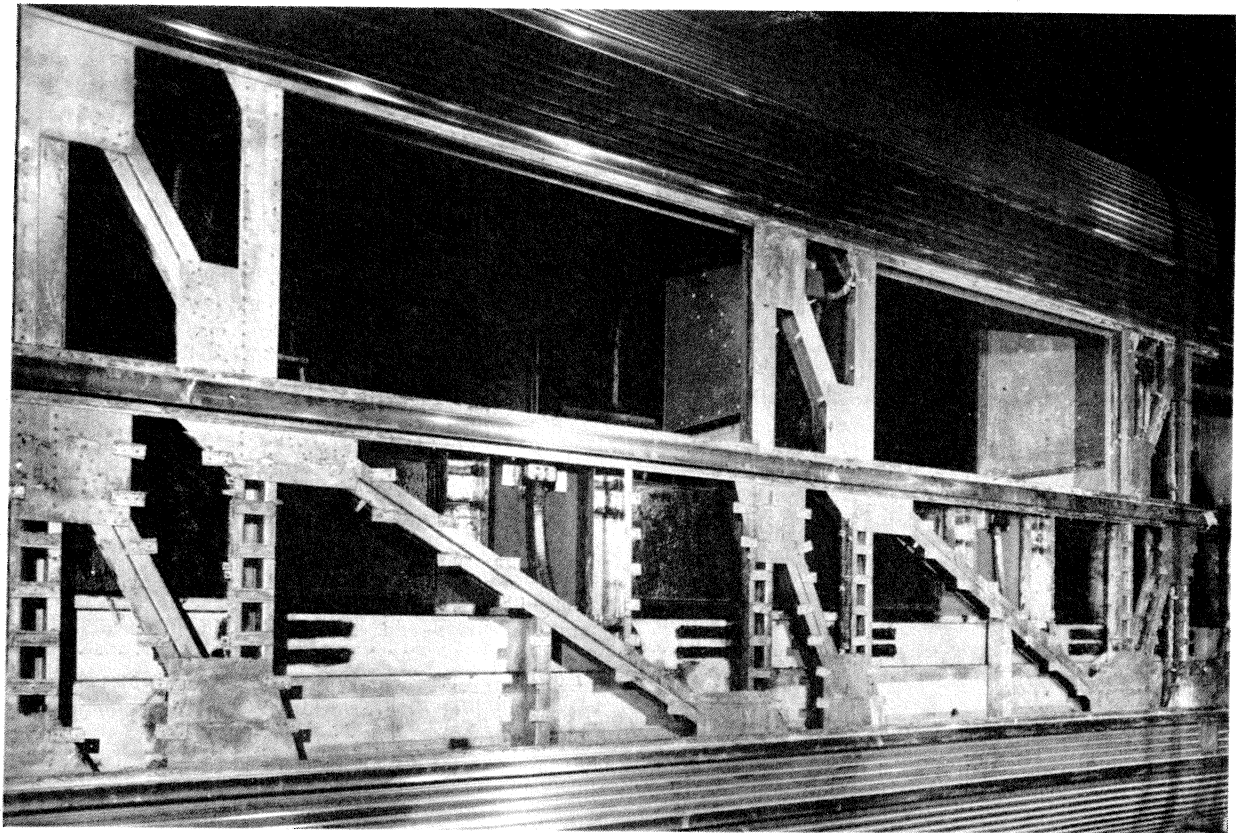
Below—Center side frame section, showing absence of corrosion after 13 years service

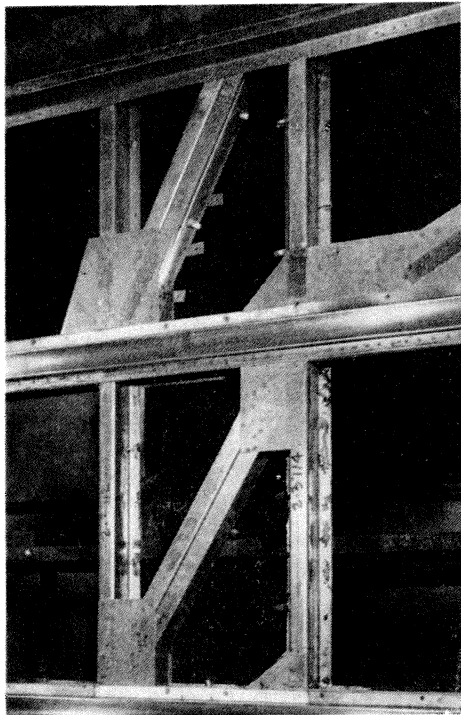
Left—Diagonal strength member at car center showing condition of stainless steel and Shotwelds

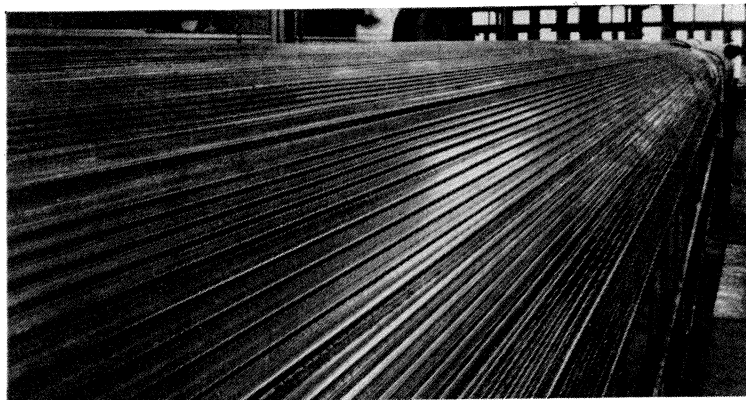
Above—The roof of one of the units after being cleaned

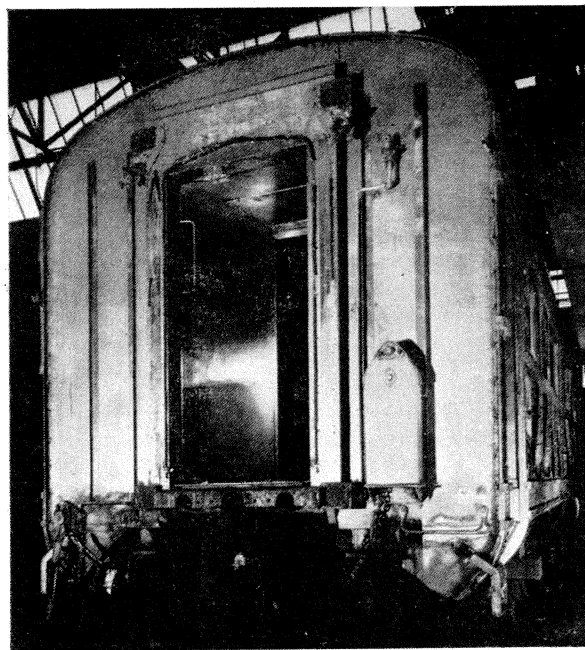
Below—End view of a coach with diaphragm and coupler removed

Some of the units in the "Denver Zephyr" trains are articulated, while others have tight-lock coupler connections. In the latter, the rear of the coupler shank has a ball, providing a universal joint. There is a front and back casting surrounding this ball, the rear casting also acting as a follower plate, and no draft gear is used. The ball wears in service, as do the front and rear socket castings, and these worn parts were built up and remachined to their original dimensions, thus taking up all slack.
